DEPARTMENT OF TRANSPORTATION

Contract #: 04-0120F4Cty: SF/ALA Rte: 80 PM: 13.2/13.9File #: 69.28**WELDING INSPECTION REPORT****Resident Engineer:**Pursell, Gary**Address:** 333 Burma Road**City:** Oakland, CA 94607**Report No:** WIR-002151**Date Inspected:** 23-Apr-2008**Project Name:** SAS Superstructure**OSM Arrival Time:** 700**Prime Contractor:** American Bridge/Fluor Enterprises, a JV**OSM Departure Time:** 1700**Contractor:** Zhenhua Port Machinery Company, Ltd (ZPMC), Changxing Island **Location:** Shanghai, China**CWI Name:** Xu Le Feng, Ye Yong Jun**CWI Present:** Yes No**Inspected CWI report:** Yes No N/A**Rod Oven in Use:** Yes No N/A**Electrode to specification:** Yes No N/A**Weld Procedures Followed:** Yes No N/A**Qualified Welders:** Yes No N/A**Verified Joint Fit-up:** Yes No N/A**Approved Drawings:** Yes No N/A**Approved WPS:** Yes No N/A**Delayed / Cancelled:** Yes No N/A**Bridge No:** 34-0006**Component:** Tower**Summary of Items Observed:**

77M Tower Mock-up Macro Etch Samples

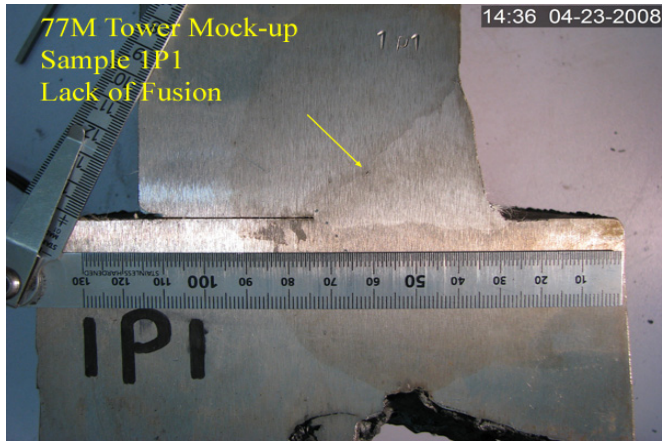
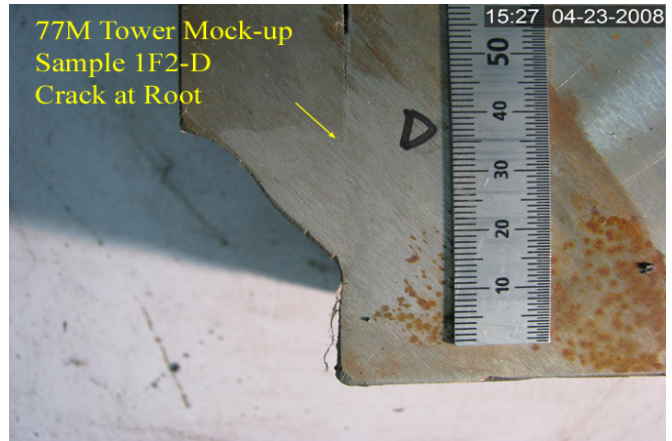
The Quality Assurance Inspector performed a visual inspection to forty two macro etch sample welds from the 77M Tower Mock up. One Sample was not provided as indicated from sample map ZPMC provided. All the data from the review was recorded in a tracking log and forwarded to Quality Assurance Task Leaders and Structural Materials Representatives. The Samples were digitally photographed and placed on the internal server for future review. Below are digital photograph of samples 1P1 which contained Incomplete Fusion and Sample 1F2-D which contained a crack in the root of the fillet weld.
